# KAFTOUN

## CONSERVATION AND RESTORATION OF THE MAR SARKIS CHURCH MURALS INTERIM REPORT

Krzysztof Chmielewski and Tomasz Waliszewski

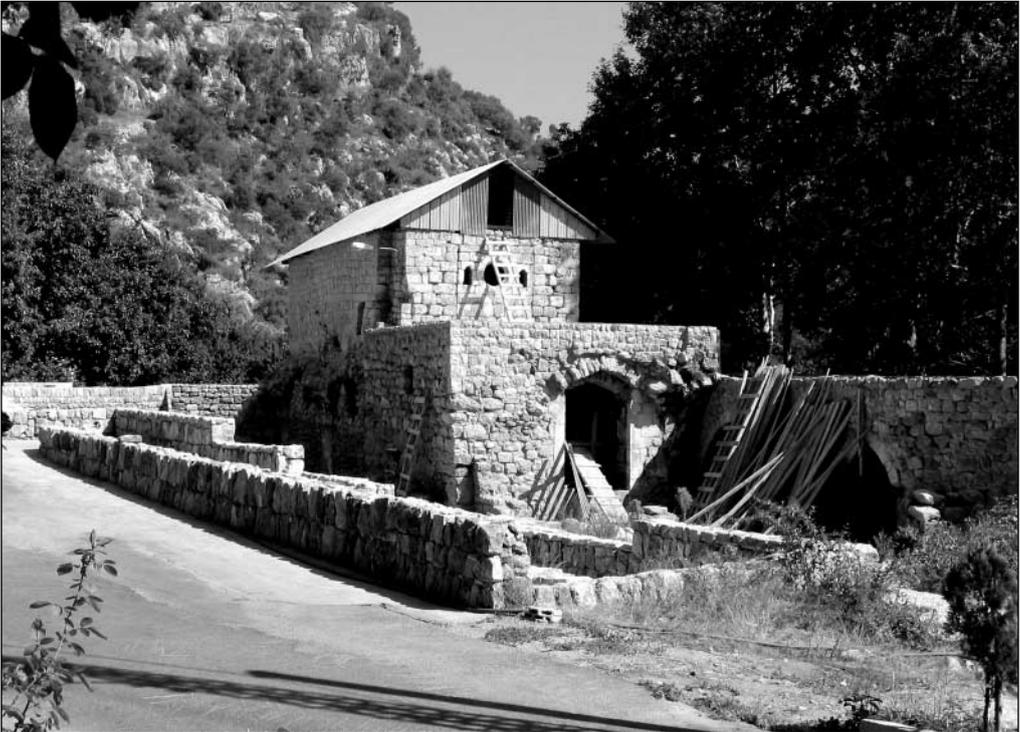
Fig. 1. *The Church of Mar Sarkis in Kaftoun, state in 2004*  
(Photo T. Waliszewski)

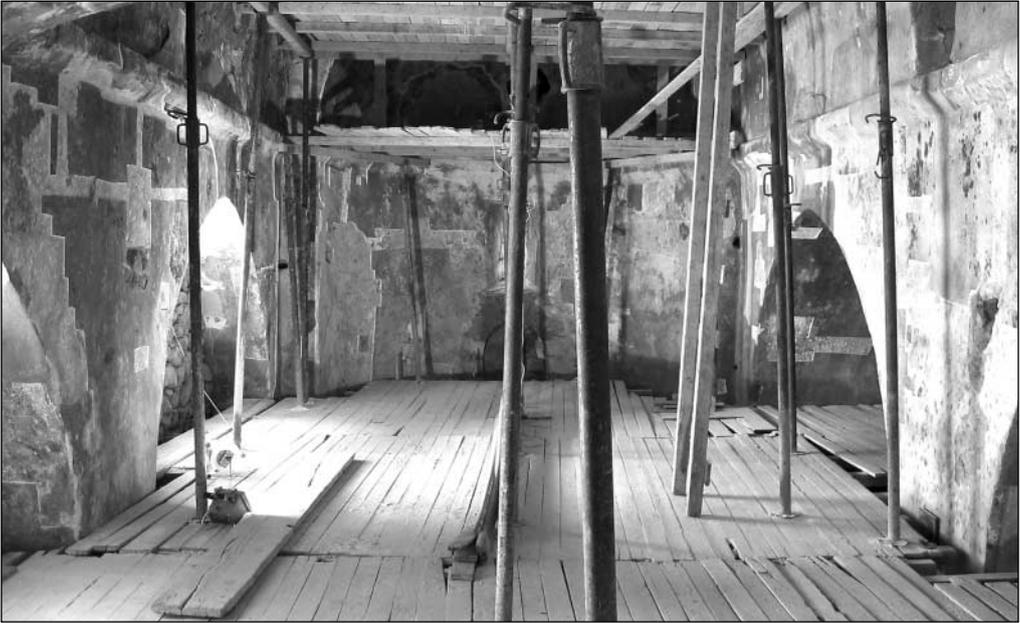
Secondary plaster on the church walls varies in thickness from 0.6 to 1.9 cm. Originally white, this lime plaster is now gray and green (due to fungi and mould deterioration) and more or less disconnected from the underlying layers in many places. Probes, ranging from 10 to 20 sq. cm, were executed through the plaster on all the walls and on the vault of the church. Knives, scalpels, chisels and hammers were used for the purpose. Whenever traces of painting were revealed, the probes were enlarged. Long and narrow probes will be executed across all of the walls and vaults to ensure that no further murals remain undiscovered [Fig. 2].

*Fig. 2. Church nave looking east, state during conservation work in 2004  
(Photo T. Waliszewski)*

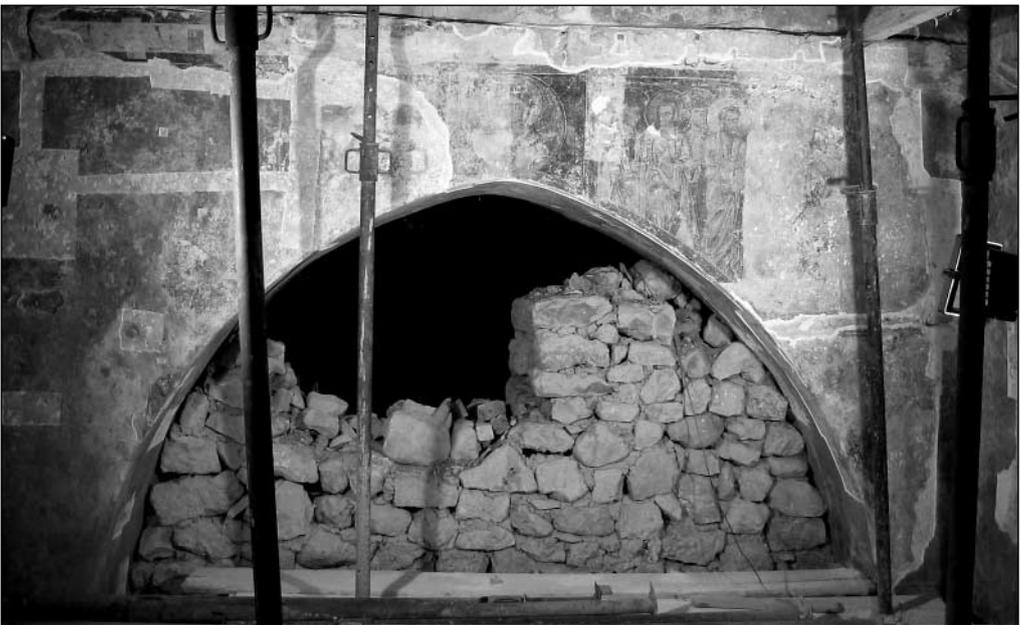
4. North wall of the nave, paintings on the cornice and below [Fig. 3]. Originally, both walls of the nave bore murals, including an inscription in Arabic running along the cornice from right to left, some scenes and a few single figures of saints or angels, all placed within border frames of deep claret color. For the moment, there are three fragments of painted plaster known from the northern wall. First from the west is a small fragment of Arabic inscription on the cornice, approximately midway along the length (maximum width 0.775 m, maximum height 0.245 m).

Between the above fragment and the end of the wall, a bigger fragment preserving

part of the inscription in Arabic on the cornice, a medallion with the bust of an angel, and a scene of what was likely a *Communion of the Apostles*. The latter consists of seven standing robed figures with halos around their heads, facing the first figure from the east, identified as Christ dispensing communion. Three Syriac inscriptions preserved above the heads of three of the figures. (Maximum width 3.83 m, maximum height 1.18 cm.)

A third, smaller fragment, situated below the above-described second fragment (between the end of the nave arch and the end of the wall close to the apse). Two fragmentary standing figures: a winged angel (on the left) and saint *Laurentios* (on the right); between them an inscription in Greek. (Maximum width 0.67 m, maximum height 1.07 cm).

*Fig. 3. North wall of the nave with uncovered traces of murals, state during conservation in 2004  
(Photo A. Karolczak)*
